**Virginia Department of Forestry**  
**Accident Investigation Report**  
**Wildwood Road Fire, Dozer Incident**  
April 21, 2023

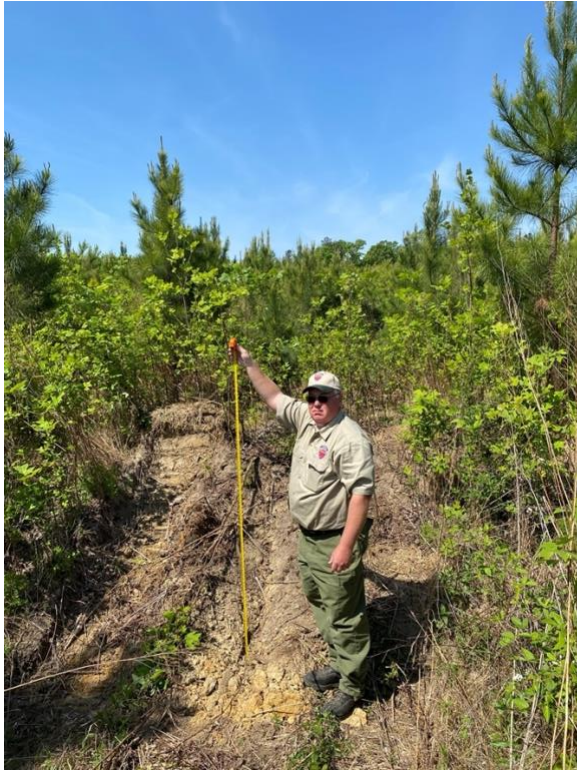
**Photo #1 –**

This thick fuel caused the operator to not see the drainage ditch prior to the entering the grassy road. The dozer suddenly dropped approximately 5 feet after striking the unseen drainage ditch.

This drop of approximately 5 feet caused the dozer blade to strike the ground in the ditch. It had been raised several feet to allow it to tram through the fuel during the reconnaissance. Striking the ground in the ditch caused the dozer to come to a sudden stop.

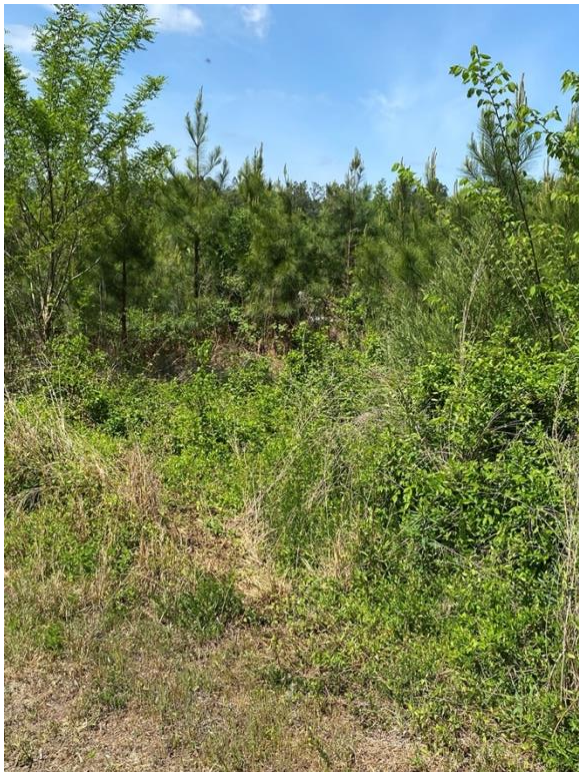
**Photo #4 –**

The fuel type was thick and difficult to navigate in a dozer, it would have been impossible for a person to safely walk through this fuel type while acting in a capacity as a "dozer lead".

As noted, the fuel in which the operator was conducting reconnaissance was extremely thick and hard see through completely to the ground from the dozer cab.
