Virginia Department of Forestry
Accident Investigation Report
Quaker Run Fire, Dozer Rollover

October 28, 2023

ACCIDENT: Dozer Rollover

LOCATION: Division Foxtrot, Quaker Run Fire, Madison County, Virginia

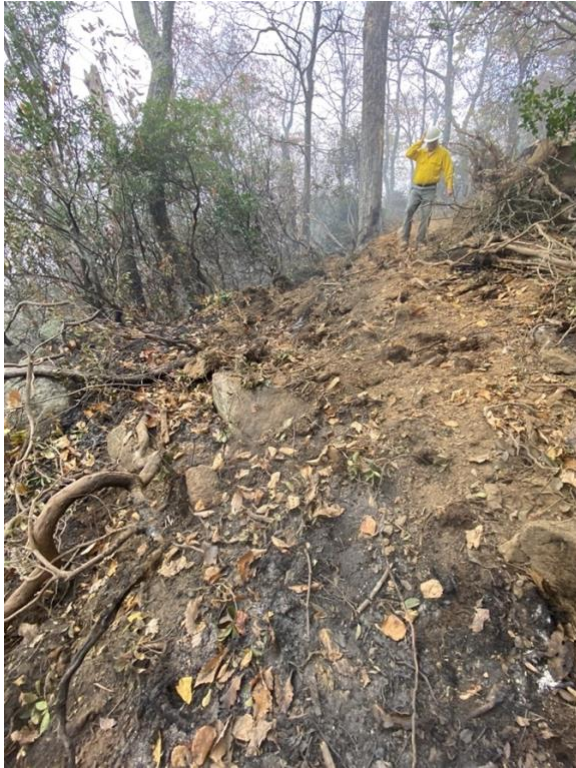
Photo #1 – View looking uphill from overturned dozer showing its line pushed downhill

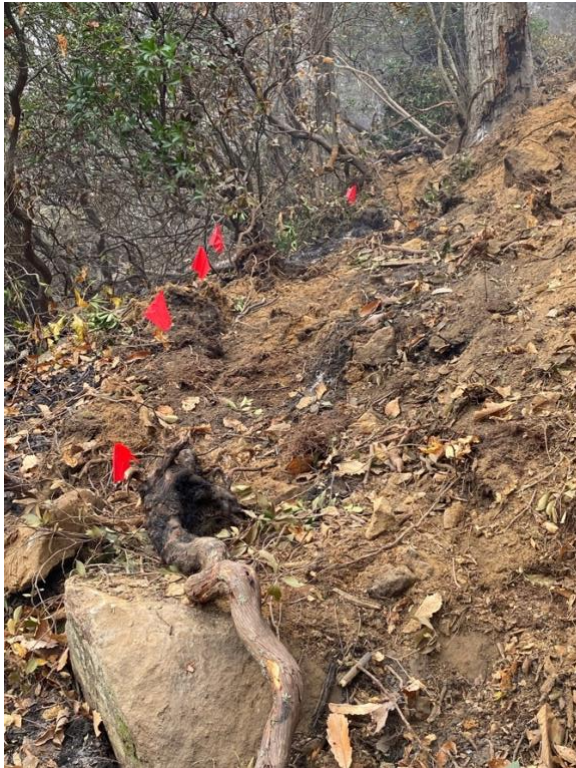
Photo #2 – Shows red pin flags and dozer's right tract marks heading towards "the rock"

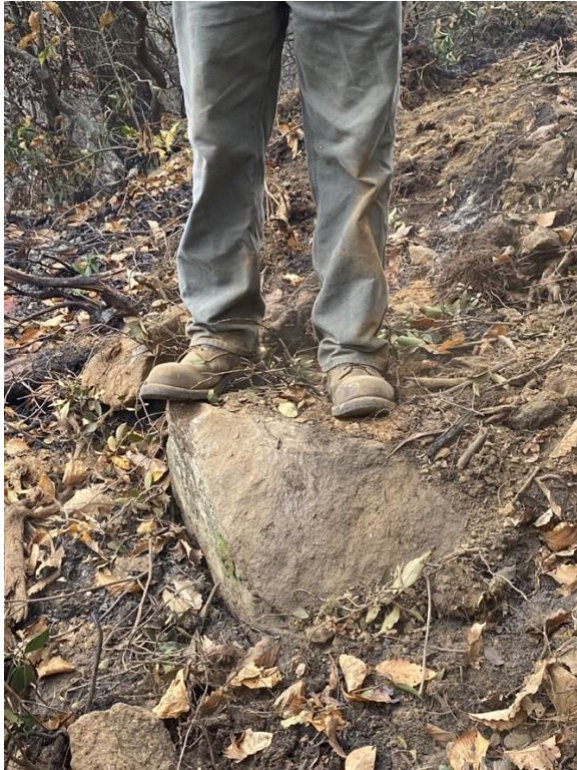
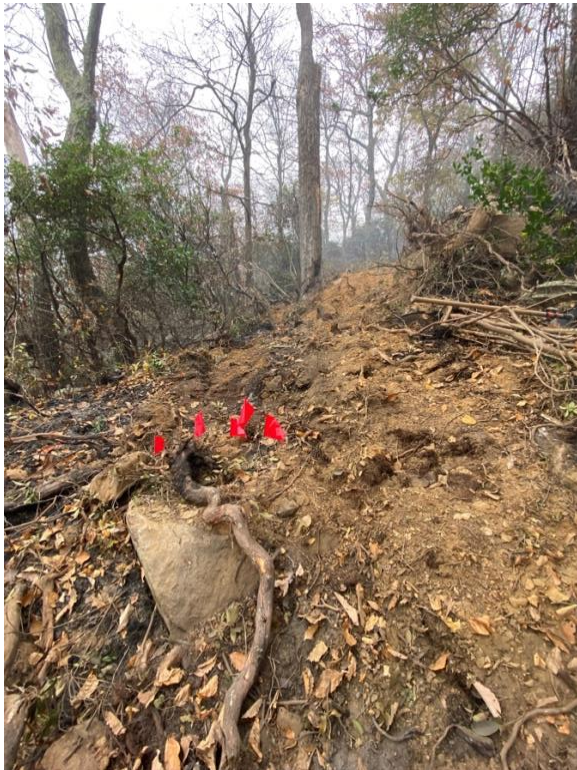
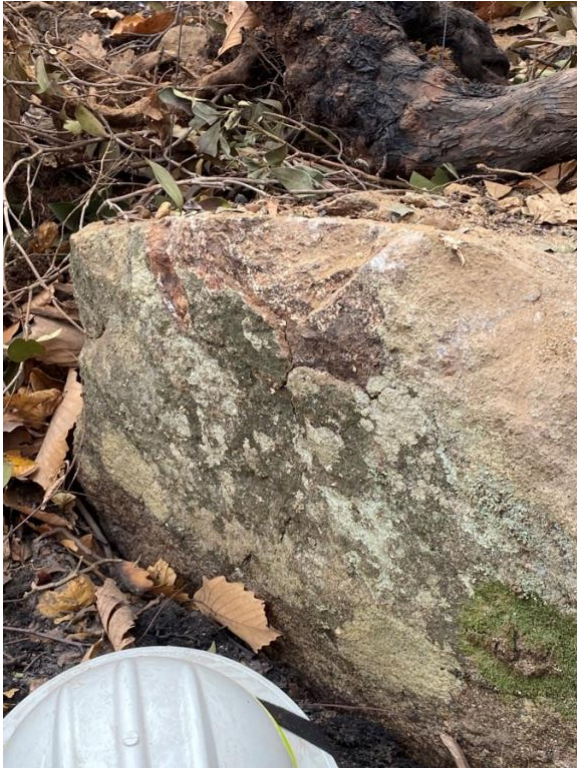
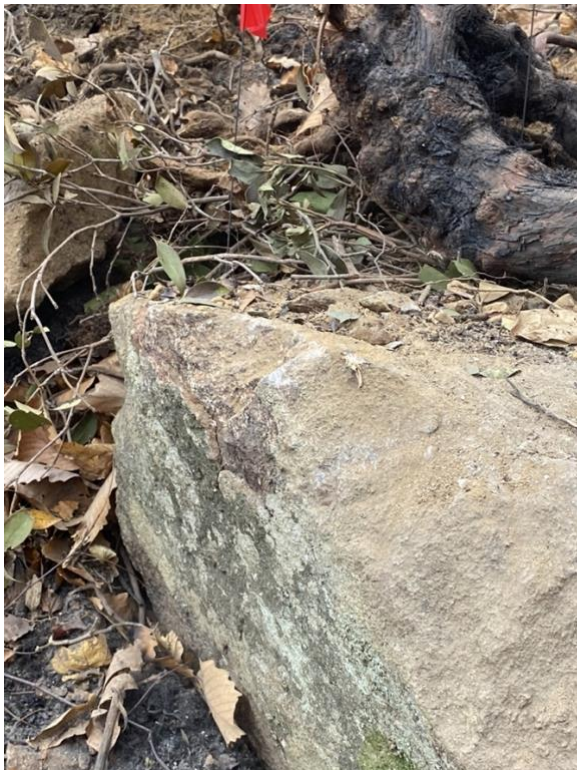
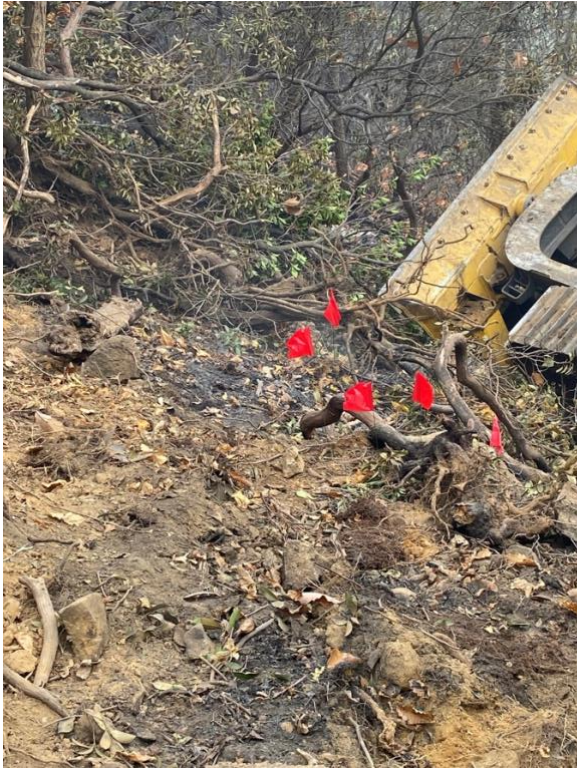
had already tried to back out and go back uphill with no success climbing the steep grade. The swamper was not in visual sight of the dozer and only had radio communication with the operator. While re-adjusting the position, the dozer's right track ran onto a rock that the operator could not see, the steep incline and weight of the dozer caused the track to slip off the rock. This caused the dozer to roll onto its roof.

Photo #3 – View of “the rock” that cracked and caused the dozer to roll.

Photo #4 – View of “the rock” that cracked and caused the dozer to roll.

Photo #5 – View of “the rock” that cracked and caused the dozer to roll.

Photo #6 – View of “the rock” that cracked and caused the dozer to roll.

Photo #7 – View of “the rock” that cracked and caused the dozer to roll.

Reinforce to dozer operators that when working in steep, rocky terrain, do not make maneuvers without the aid of a swamper within visual and audible communication.

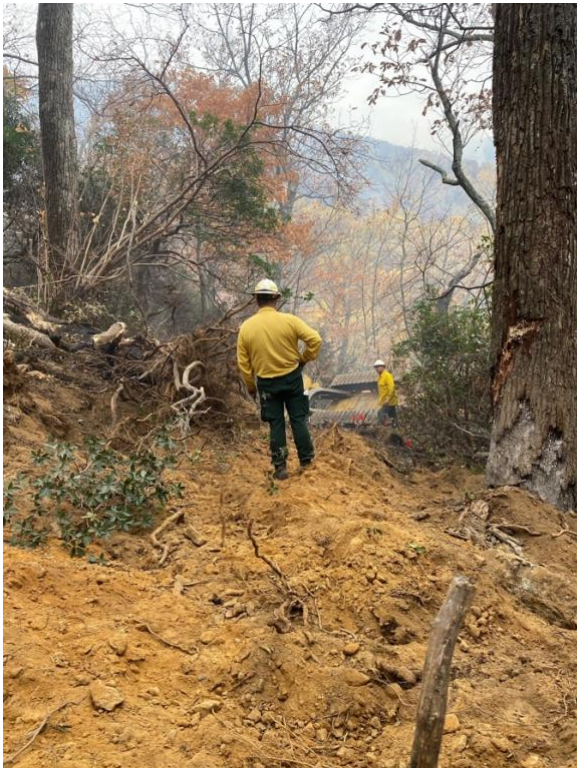
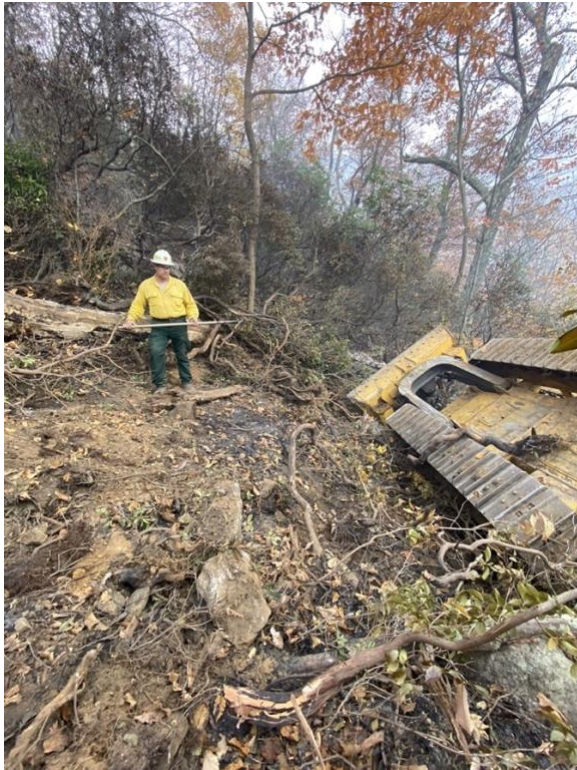
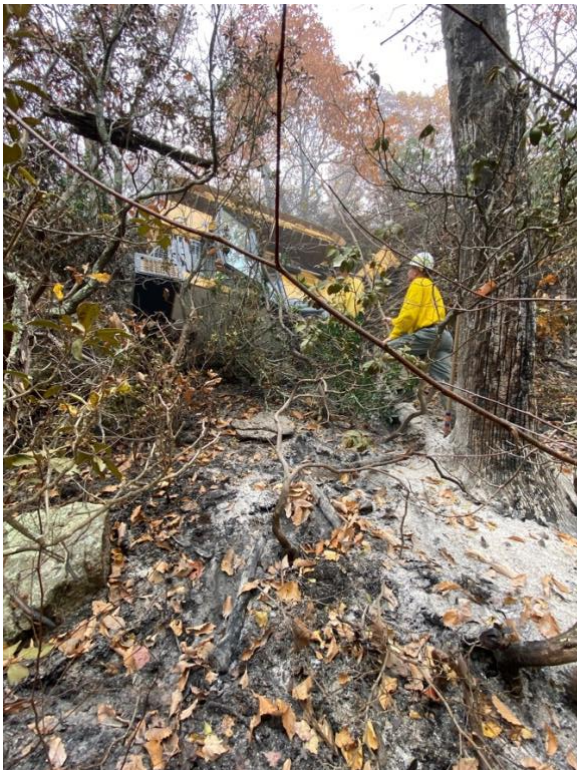
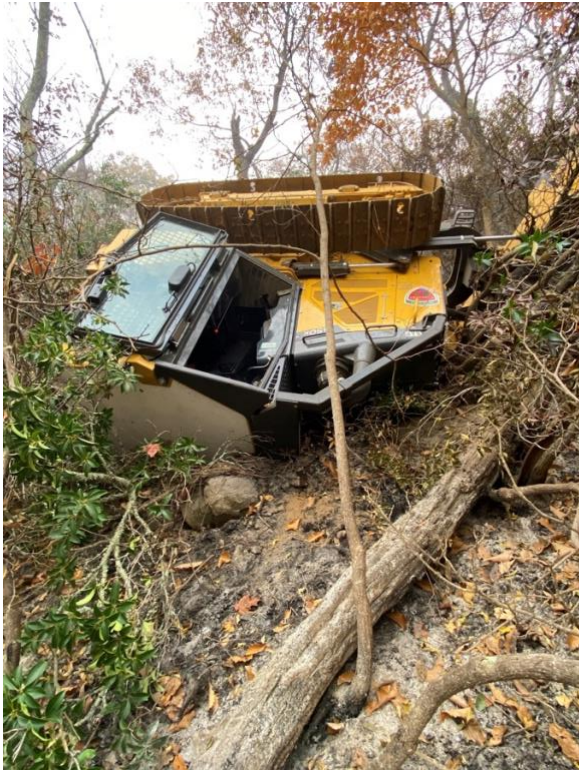
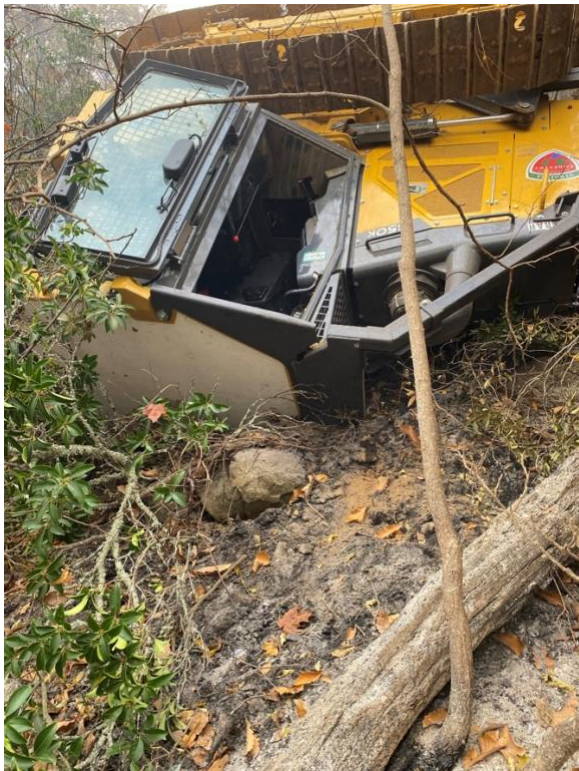
Photo #8 – Dozer final resting spot with views from several angles.

Photo #9 – Dozer final resting spot with views from several angles.

Photo #10 – Dozer final resting spot with views from several angles.

Photo #11 – Dozer final resting spot with views from several angles.

Photo #12 – Dozer final resting spot with views from several angles.

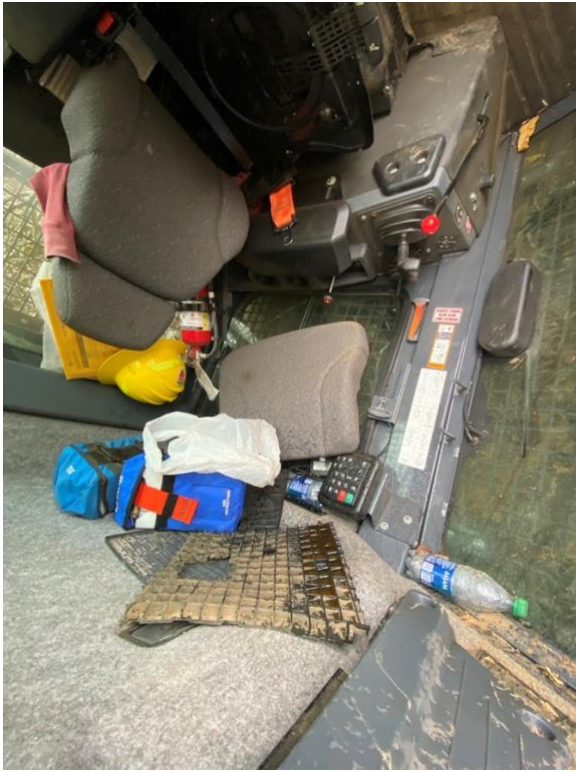
Photo #13 – Dozer final resting spot with views from several angles. Note loose items in the cab that can become projectiles in a rollover situation.

Always have items in the dozer cab secured. In the event of a rollover, those items will become projectiles and can cause injuries.
