**Virginia Department of Forestry**  
**Accident Investigation Evaluation Report**

**ATV Fatality**

March 9, 2023

**ACCIDENT:** All-Terrain Vehicle Rollover Fatality

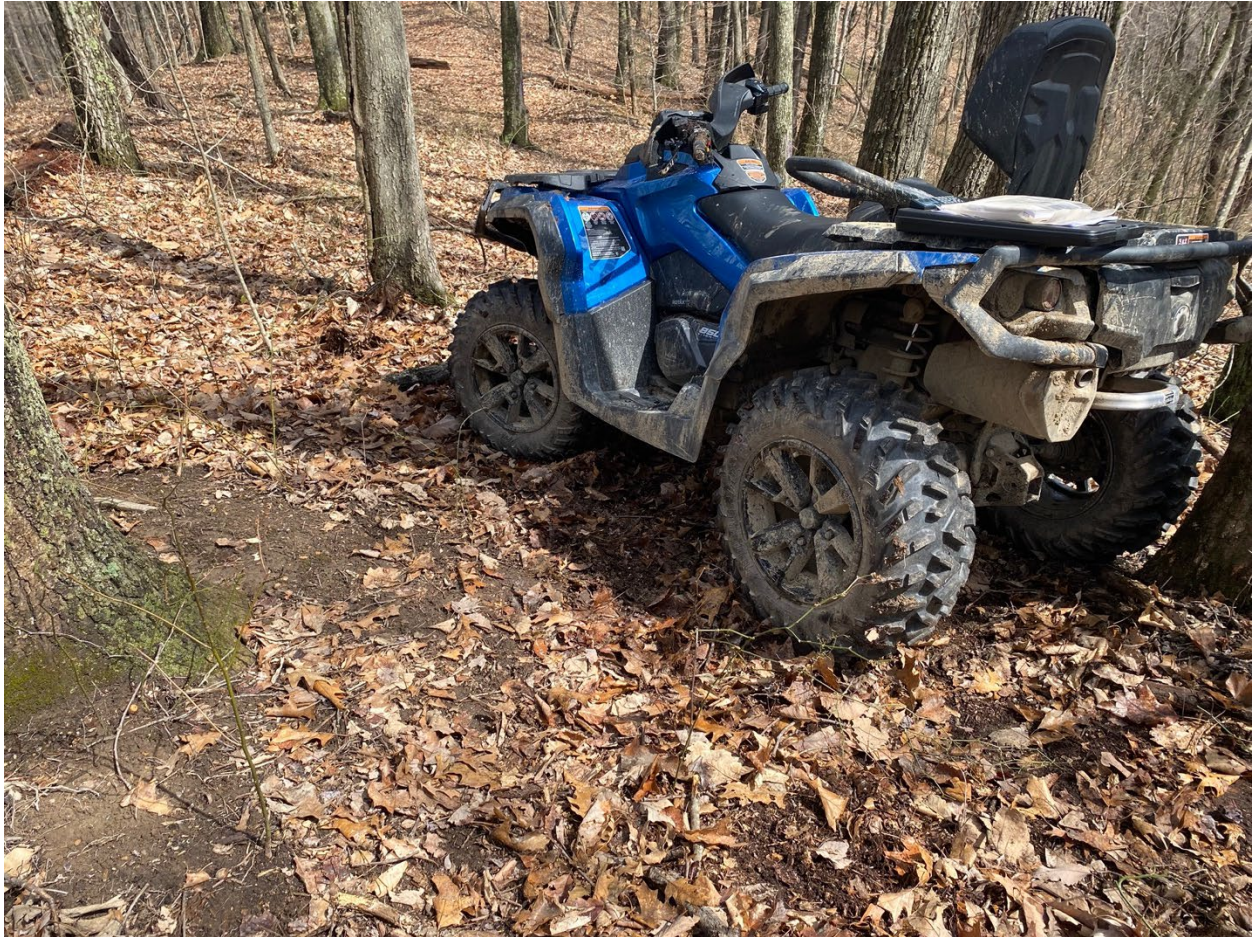
At approximately 19:45, the victim was located lying underneath the overturned ATV in a wooded area at the top of a small ridge between two trees by another DOF forest technician (photo 1.). The DOF technician attempted to free the victim from the ATV but was unable due to the weight of the vehicle. Within a few minutes, a local landowner and a DOF part-time employee arrived at the accident scene. With their combined strength they were able to free the victim and move him a short distance to a roadbed below the accident scene. The victim was wearing a long-sleeve shirt, pants, boots and a radio chest harness. A hardhat was found at the accident scene close to the ATV. The victim was not breathing and had no pulse. At that time, the personnel knew he was deceased.

2. Shows area where victims body was found trapped underneath the ATV.

*(Note: ATV has been up righted in this picture contrary to how it was found after accident.)*

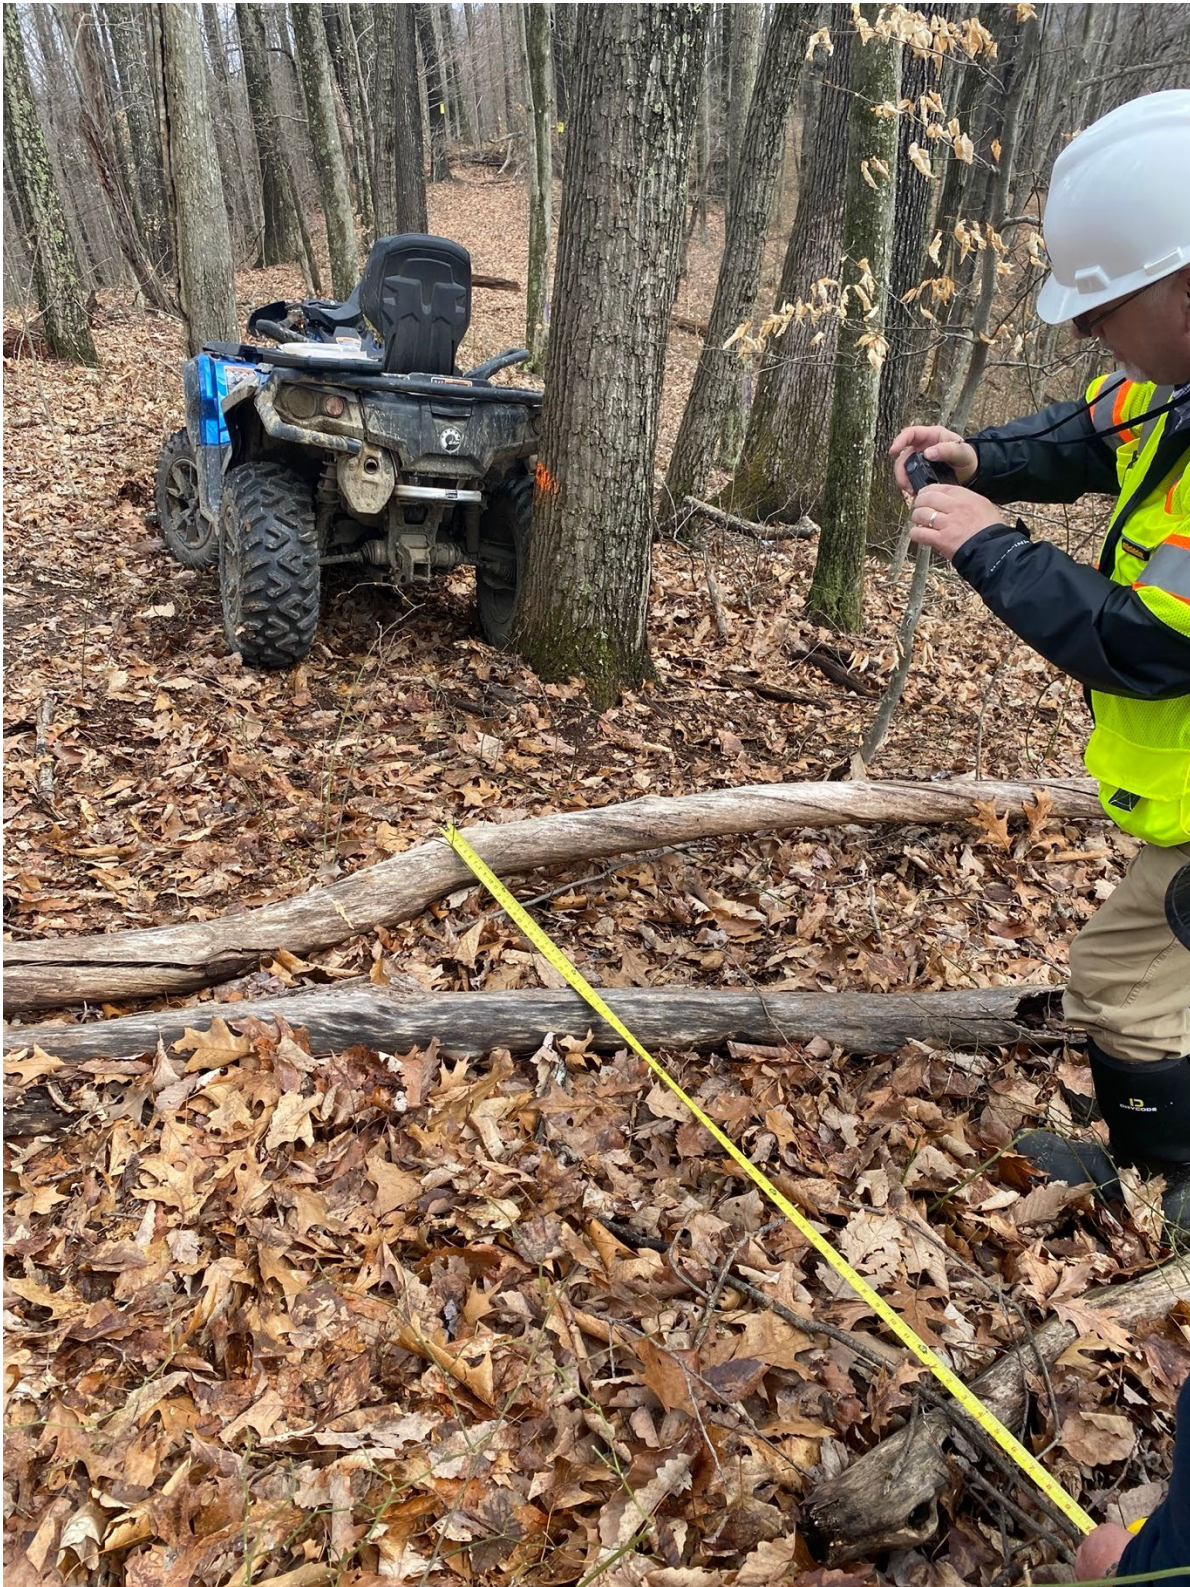
A large, forked tree branch was found on the ground in the ATV's direct path of travel.

**3. View of the direction of travel of the ATV with view of forked tree near tape measure.**

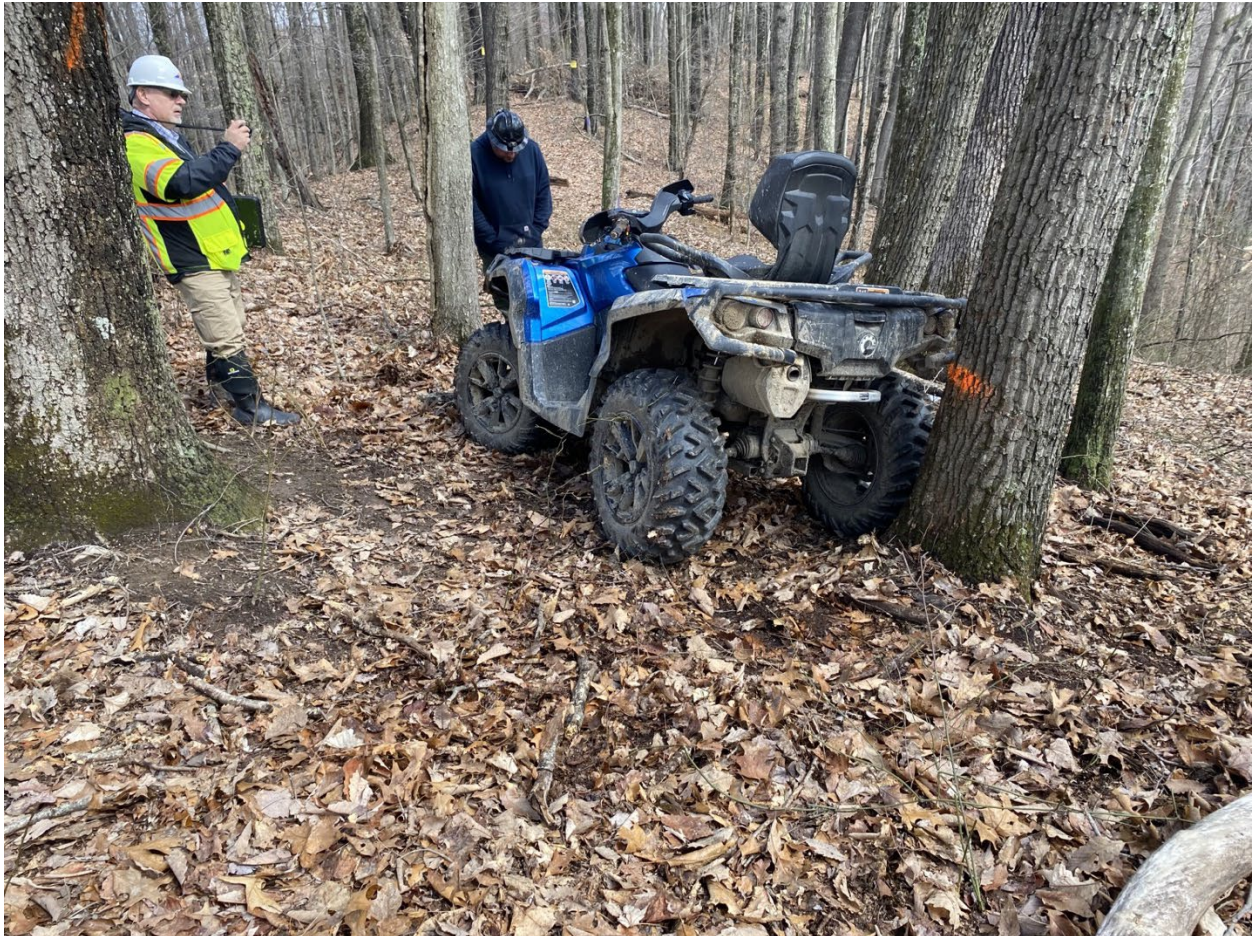
Once the ATV front wheels were off the ground it easily climbed a tree while in low gear/sport mode and with 4-wheel drive engaged, the tree was directly in front of the machine on the victim's right side. This caused the ATV to rollover onto its left side, thus trapping the victim underneath.

4. View of the ATV against the tree that it is believed to have partially climbed with the right front wheel. This is what is believed to have caused the ATV to overturn.

Replacing all ATVs with UTVs that possess rollover protection structures, seatbelts and windshields would greatly increase the overall safety of personnel travel in the work environment.

If the agency chooses to continue the use of ATVs, all existing ATVs should be retrofitted with roll cages to protect riders in the event of a rollover accident.

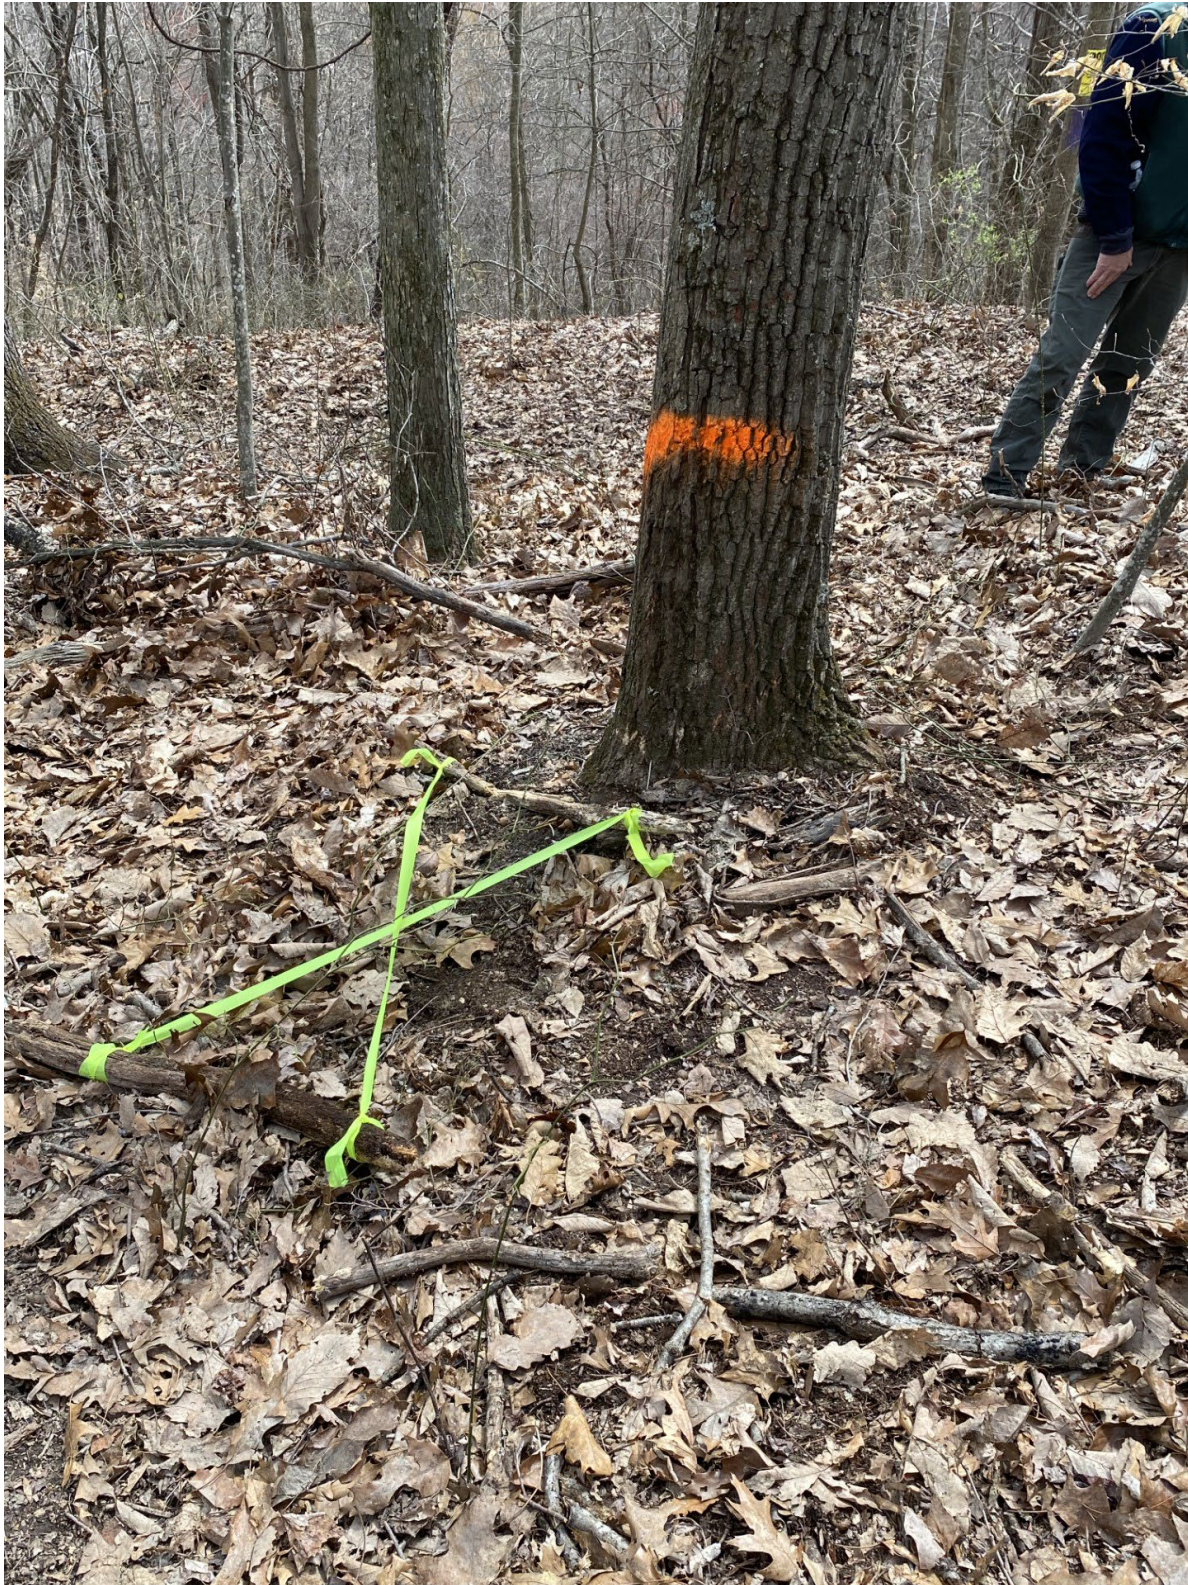
5. Further views of the tree depicting gouges in the bark illustrating where the ATV is believed to have climbed.

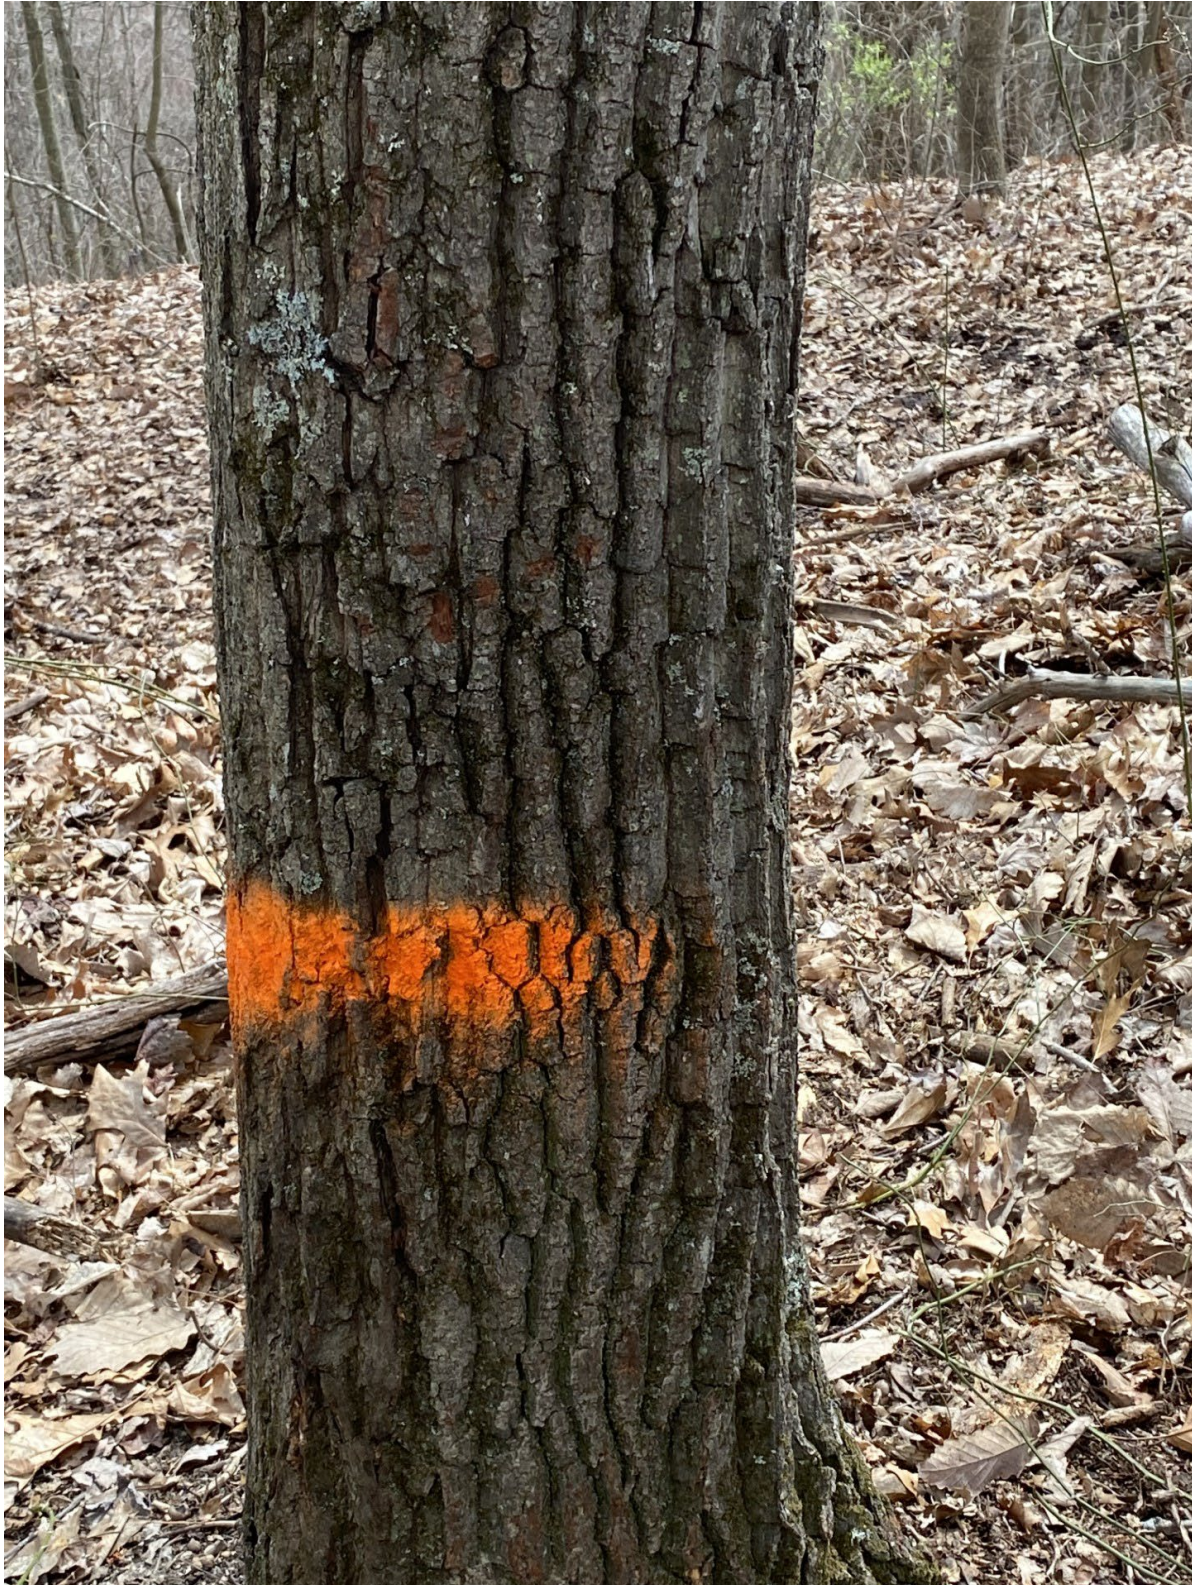
6. Further views of the tree depicting gouges in the bark illustrating where the ATV is believed to have climbed.

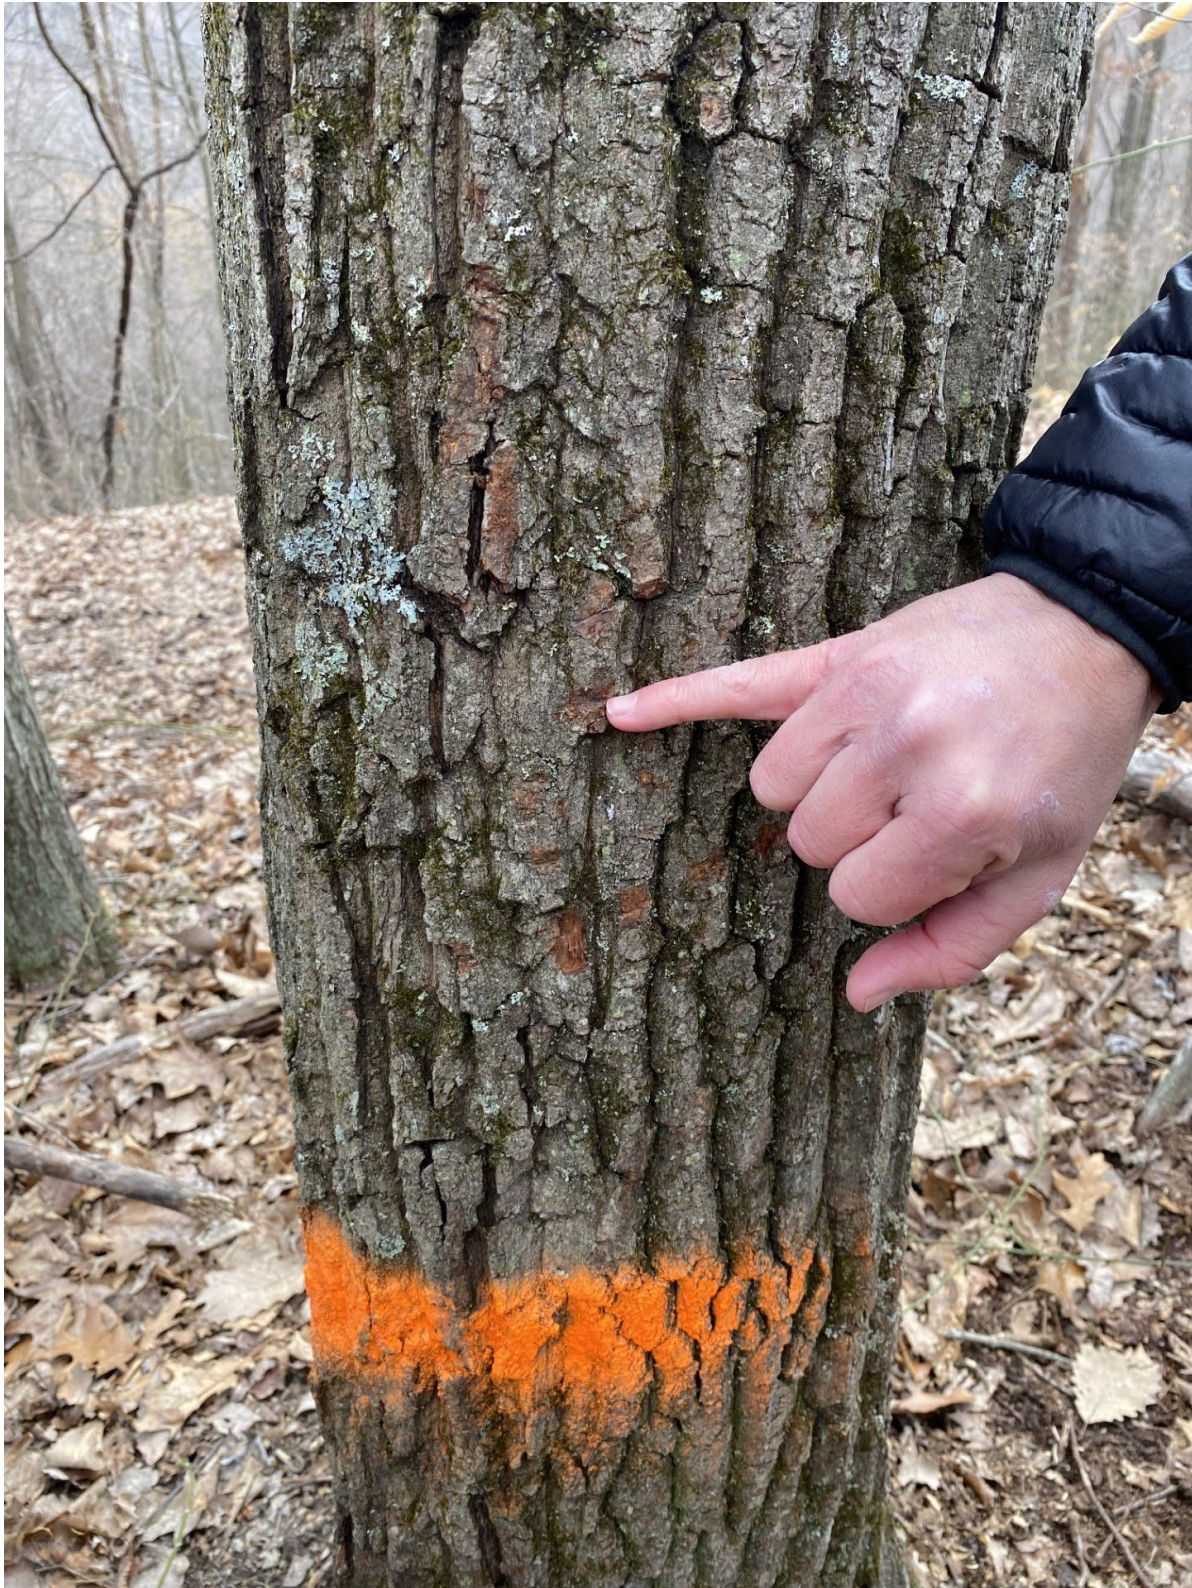
7. Further views of the tree depicting gouges in the bark illustrating where the ATV is believed to have climbed.

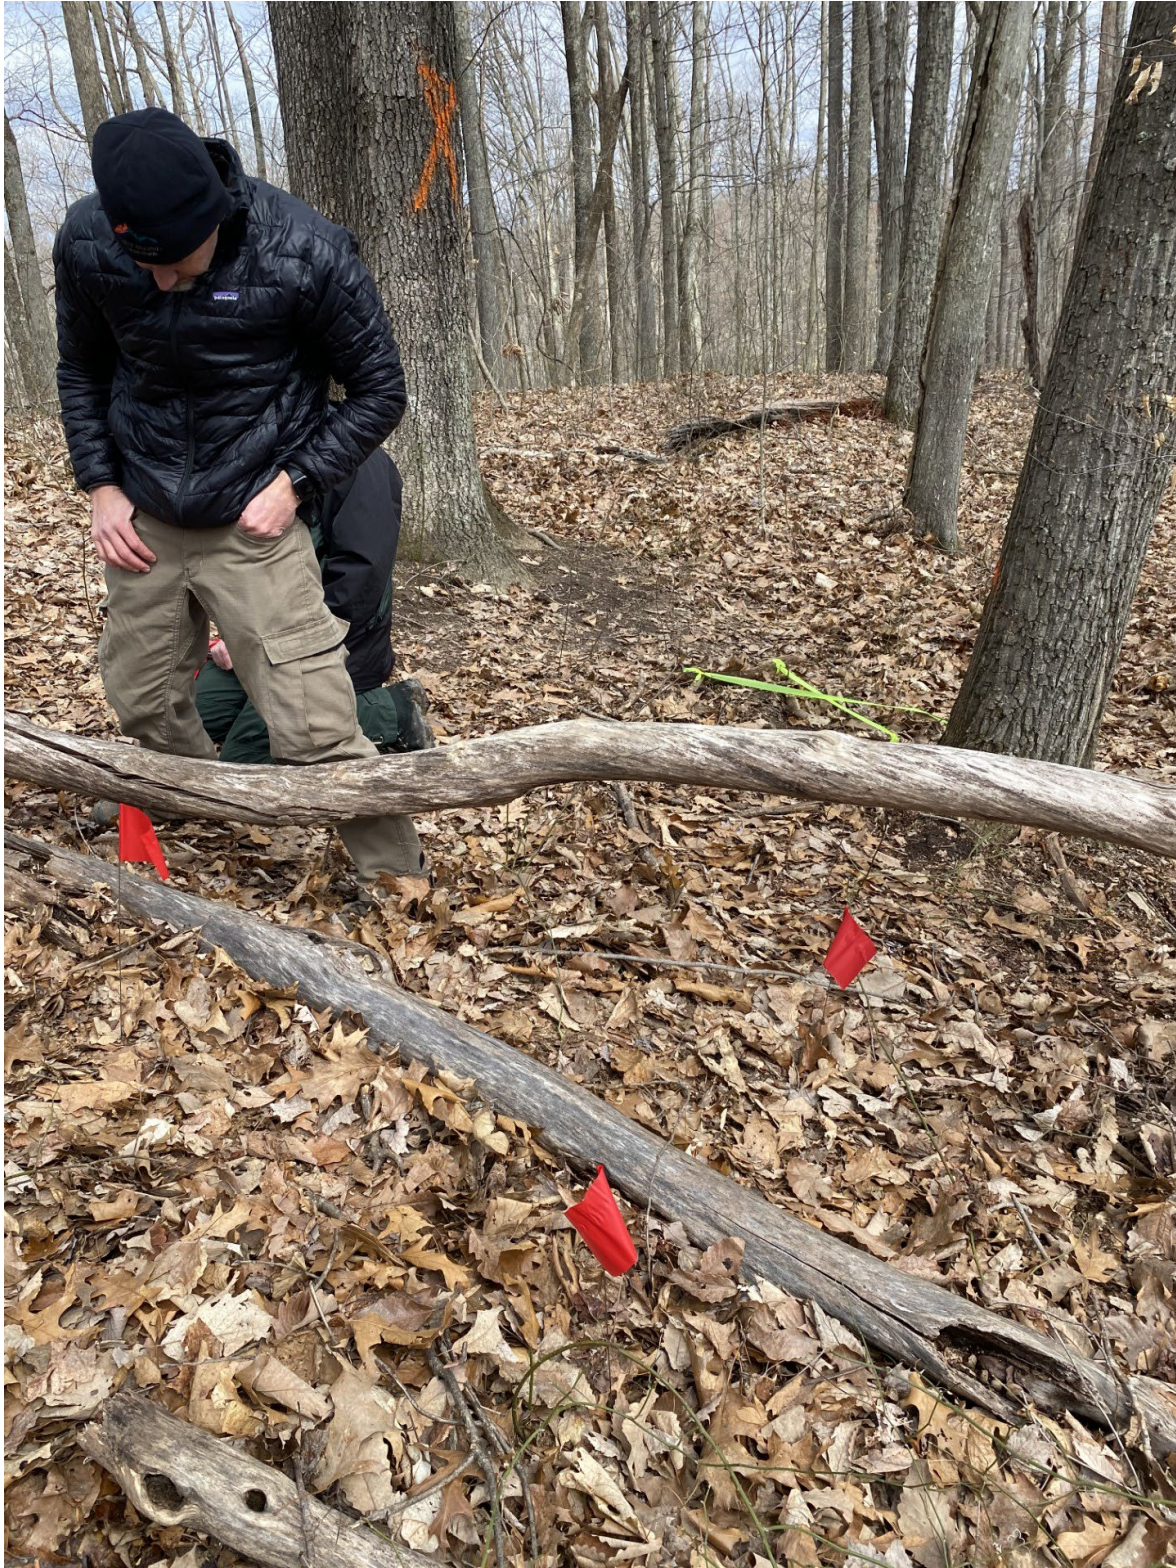
Large, forked tree branch elevated off the ground at an angle from 6-26 inches above ground level.

Victim attempted to drive over an elevated, large, forked tree branch that subsequently caused the ATV front wheels to raise up off the ground.

**8.** Views of the forked tree branch position and approximate height encountered by the victim while scouting for placement of bulldozer line (red flags show track marks in leaf litter). These tracks are in accordance with the direction of travel of the victim on the ATV.

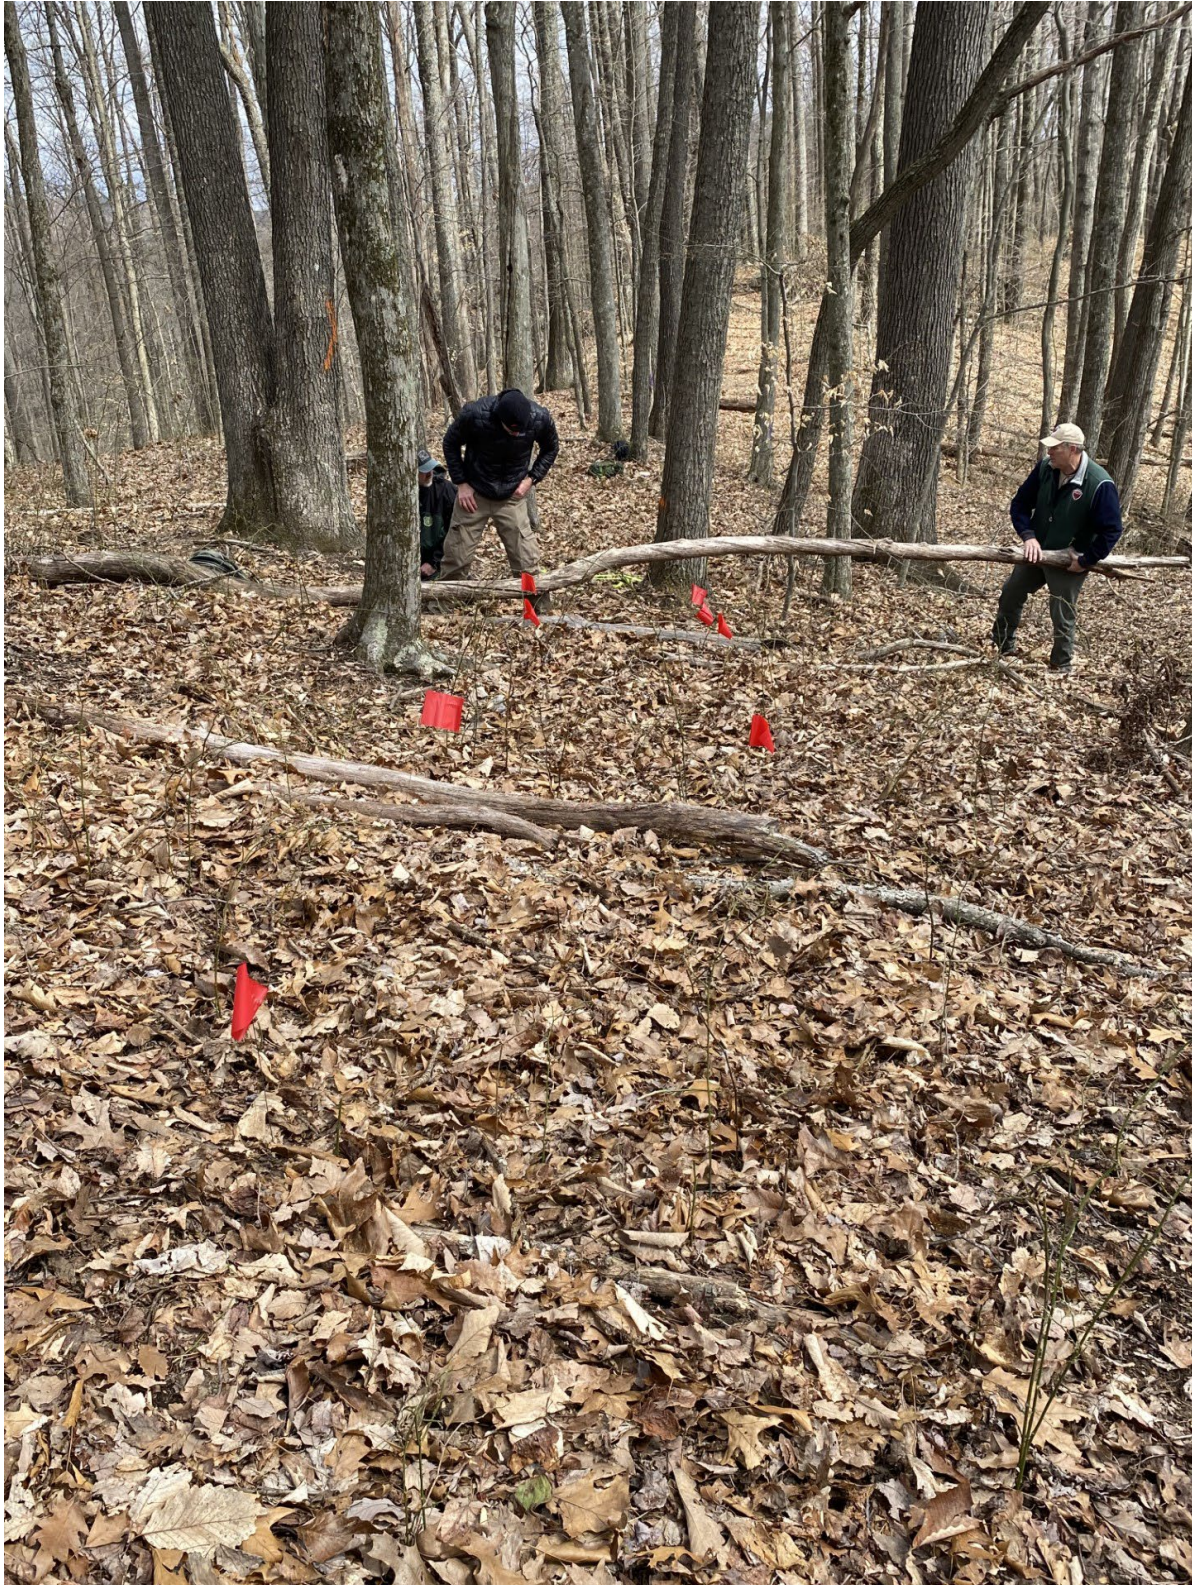
9. Views of the forked tree branch position and approximate height encountered by the victim while scouting for placement of bulldozer line (red flags show track marks in leaf litter). These tracks are in accordance with the direction of travel of the victim on the ATV.

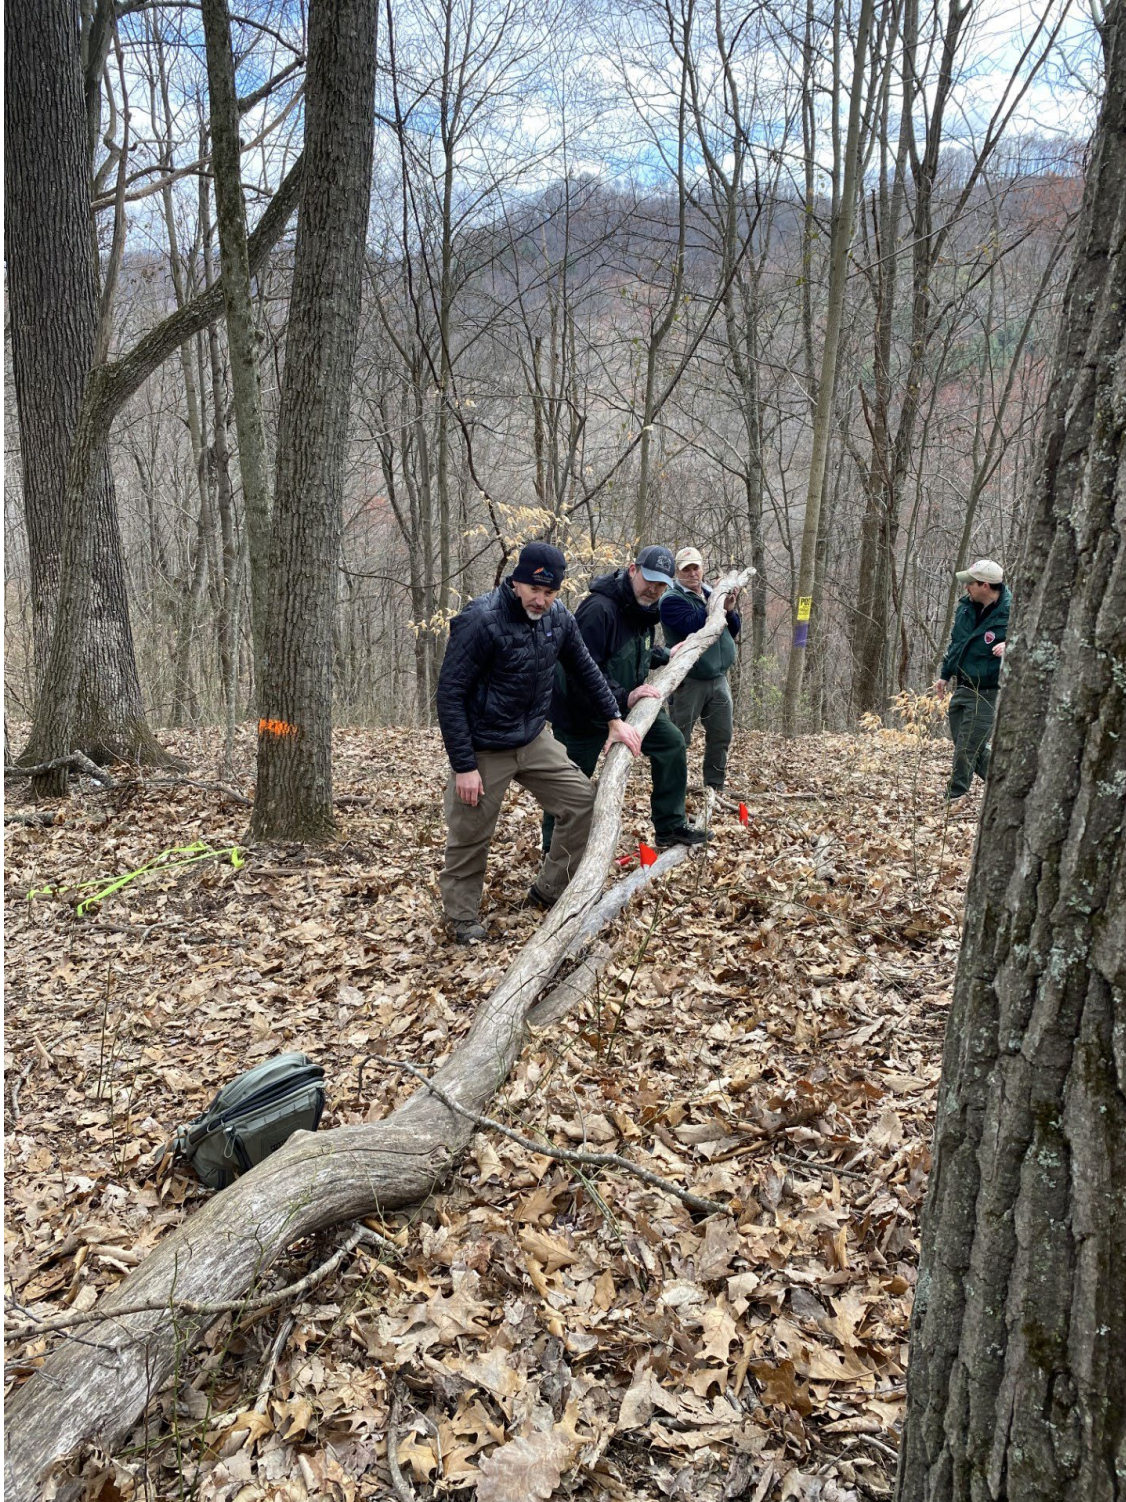
10. Views of the forked tree branch position and approximate height encountered by the victim while scouting for placement of bulldozer line (red flags show track marks in leaf litter). These tracks are in accordance with the direction of travel of the victim on the ATV.

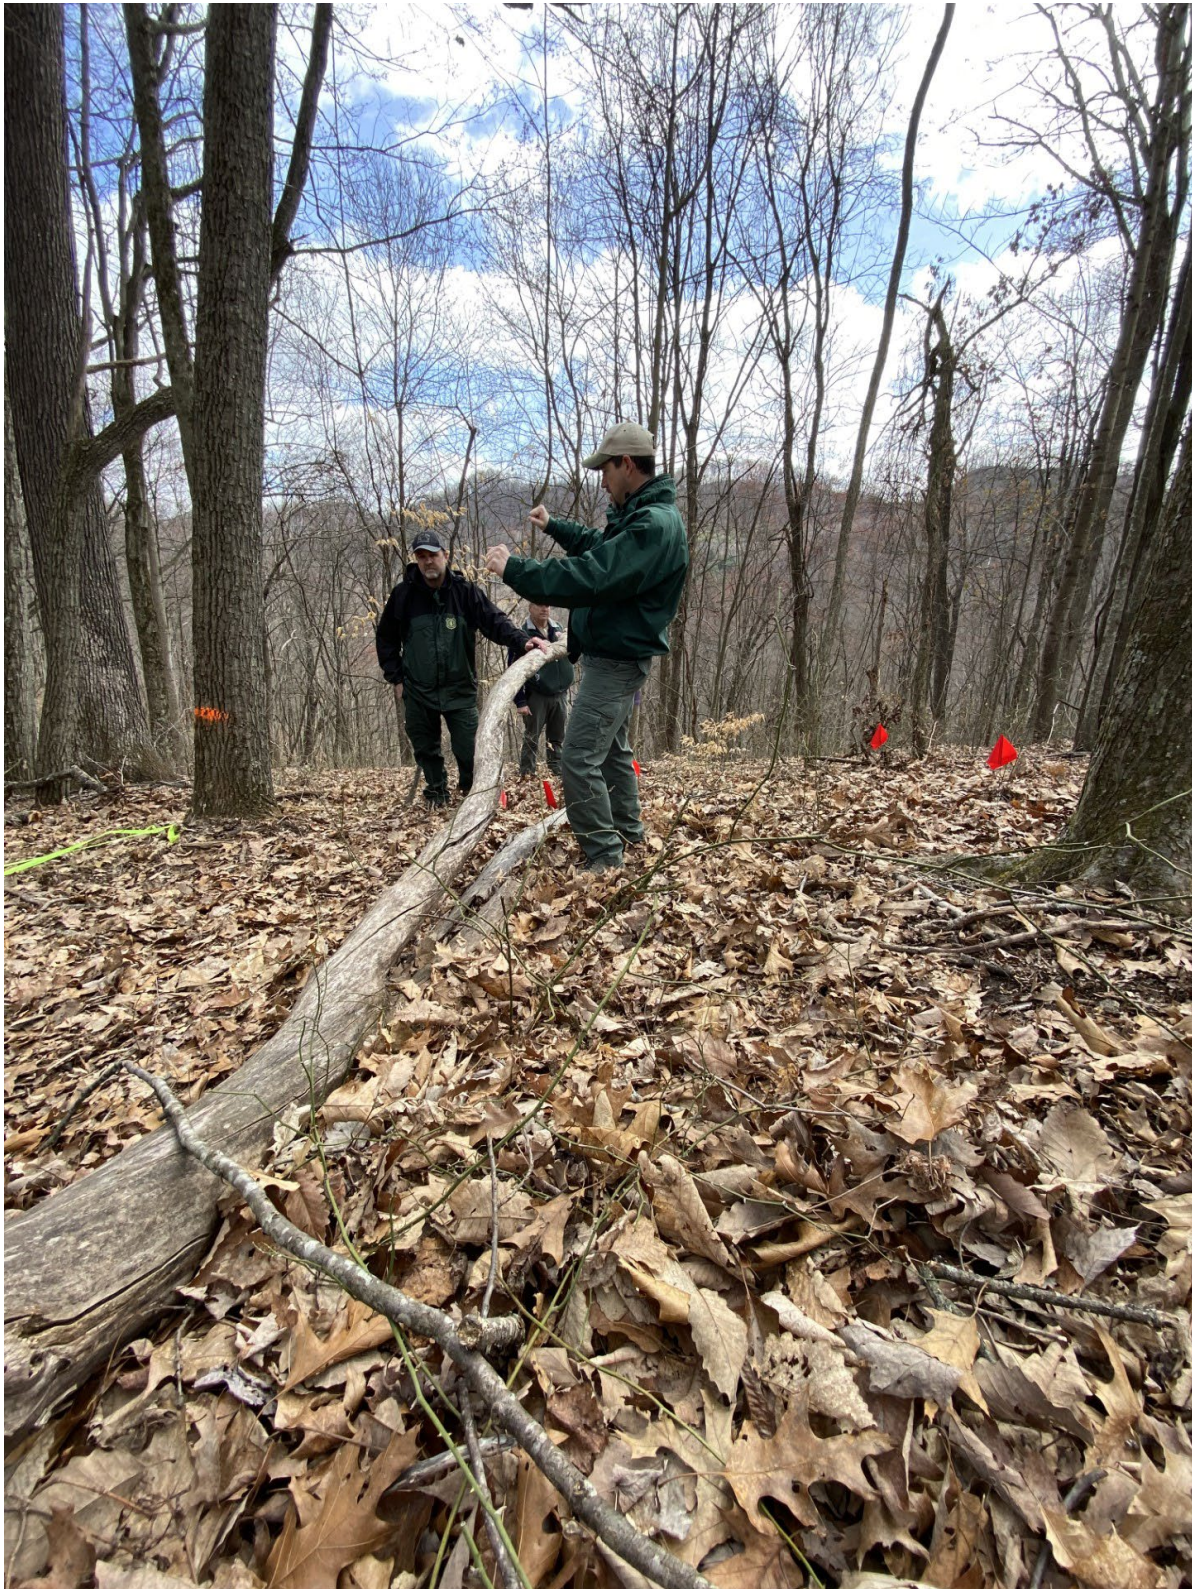
**11. Side view of the forked tree branch and its approximate height encountered by the rider.**
