**Virginia Department of Forestry**  
**Accident Investigation Report**  
**Wildwood Road Fire, Dozer Incident**  
April 21, 2023

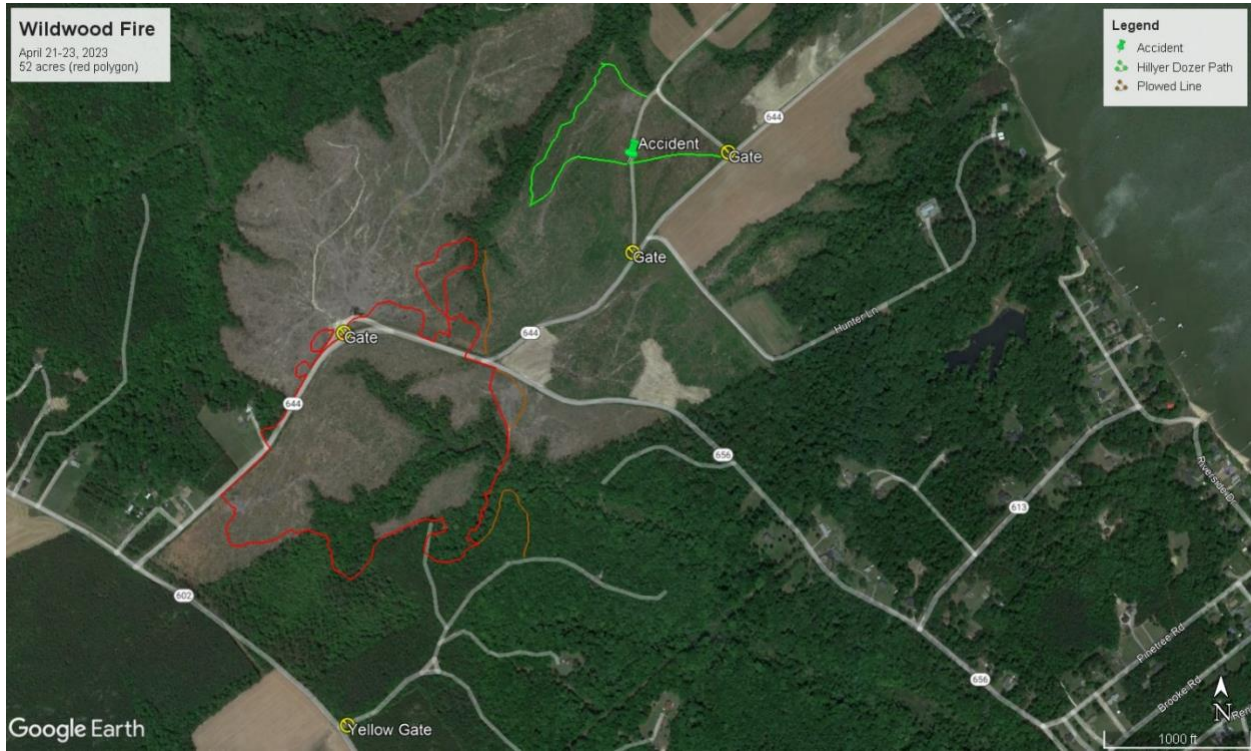
**Map #1** – Wildwood Road Fire Map. Incident occurred within the green highlighted area and red highlighted area denotes fire perimeter.

ESS-50 entered the pine/brush fuel type and conducted its spot fire reconnaissance. With no fire found, ESS-50 began to return towards a grass roadway that would connect it to the gravel road and its original entry point. As ESS-50 approached the grassy road, it suddenly and without warning dropped in excess of 5 feet down causing the blade which was lifted several feet up to allow for tramming through the pine and brush to strike the ground. This sudden striking of the blade on the ground caused a sudden stop of the dozer, ultimately causing the operator to lurch

forward. This sudden lurch forward caused the operator's seat belt to become unfastened and allowed the operator to strike their face and head on the dash area.
