Silvicultural Best Management Practices Implementation Monitoring for Virginia

2009

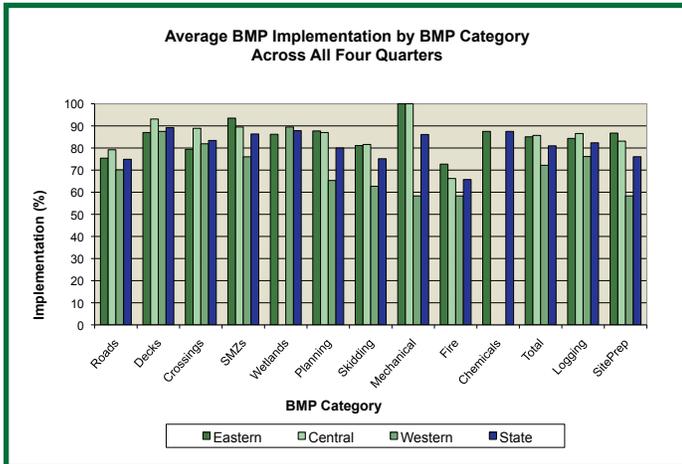
Figure 1: Average BMP implementation by BMP category, including all three regions and statewide average in the 2009 audit cycle in Virginia.

The data for the 2009 audit are displayed as a series of tables and charts below. Table 1 and Figure 1 display overall average data for the entire state by BMP category. Confidence in the mean proportions is reported as the margin of error that would be appropriate for a confidence interval with a 95 percent confidence level and was calculated according to the SGSF protocol and generally-accepted statistical procedures.

These results are also displayed graphically in Figure 1. The total number of audit tracts in this audit cycle is 240, and Table 3 shows that not all categories were applicable to every tract. These data indicate that very little site preparation (fire, mechanical and chemical) is taking place up to six months after harvest, and less than half of all audit tracts had at least one stream or wetland crossing. It is apparent that two very important categories (roads and skid trails) often lead to water quality concerns and tend to lag behind other categories with regard to implementation percentage. This is particularly obvious in the western region of the state (Tables 2 and 3).

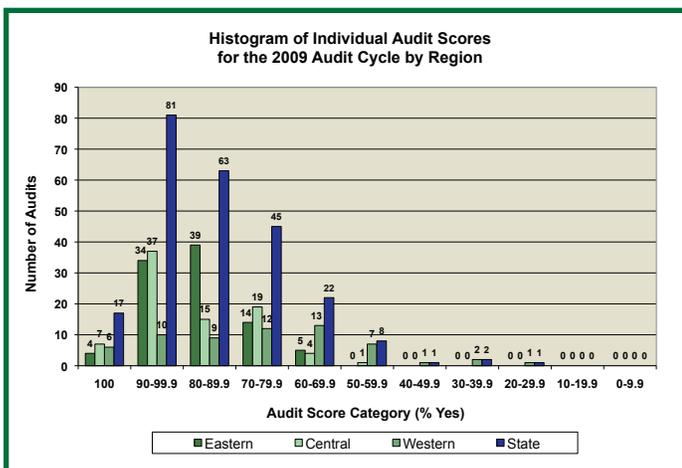
Figure 2: Score distribution of all 240 audits for the 2009 audit cycle in Virginia. Data labels indicate number of audits in each category.

The histogram in Figure 2 indicates that the vast majority of tracts scored an overall implementation percentage of 70 percent or greater. While the overall mean implementation for all tracts is 81.6 percent (Table 2), the median is 85 percent. Given the skewed distribution of the overall scores in Figure 2, the median is perhaps a better judge of central tendency of the data.

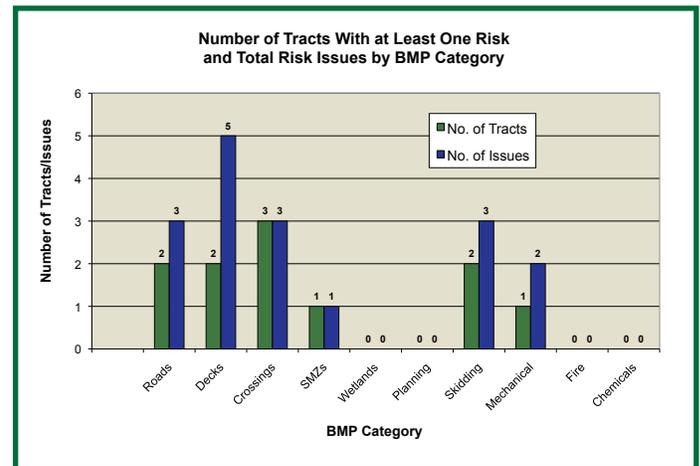
Figure 3: Number of audit tracts with at least one significant risk and total risk by BMP category. Some tracts had multiple risks in multiple categories.

was occurring. Audits that indicated a significant risk were isolated and evaluated independently of all other audits in Figure 3 below. Out of the 240 tracts in this audit cycle, nine (3.8 percent) had at least one significant risk and seven of those tracts (2.9 percent) had an active sedimentation concern.

It is apparent in Figure 3 that tracts, which had at least one risk, often had multiple risks. A second analysis - including only tracts with at least one risk-determined that the average "Percent Yes" score for those nine tracts was 65 percent, which indicates that significant risks to water quality tend to occur on tracts where overall BMP implementation is poor. Only two of the nine risk tracts had an overall score in excess of 80 percent. Significant risks to water quality obviously occur in a small minority of cases. Individual BMP issues that are often associated with significant risks are included in Table 4.
