Silvicultural Best Management Practices Implementation Monitoring for Virginia

2010

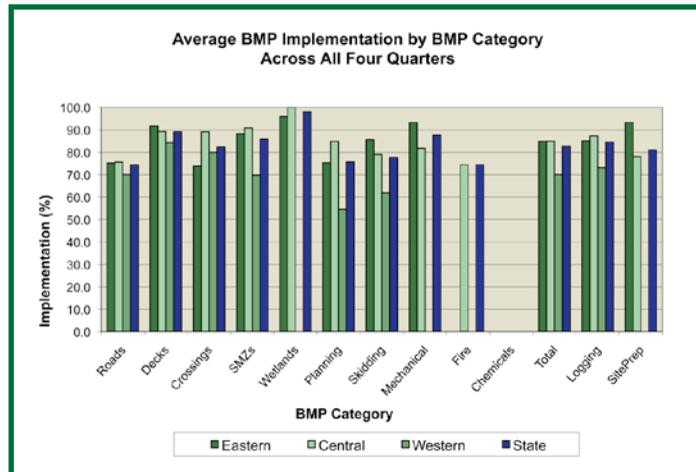
Figure 1: Average BMP implementation by BMP category, including all three regions and statewide average in the 2010 audit cycle in Virginia.

The data for the 2010 audit are displayed as a series of tables and charts to follow. Table 2 and Figure 1 display overall average data for the entire state by BMP category. Confidence in the data is reported as a 95 percent margin of error and was calculated according to the SGSF protocol and generally accepted statistical procedures.

These results are also displayed graphically in Figure 1. The total number of audit tracts in this audit cycle is 240 and Table 3 shows that not all categories were applicable to every tract.

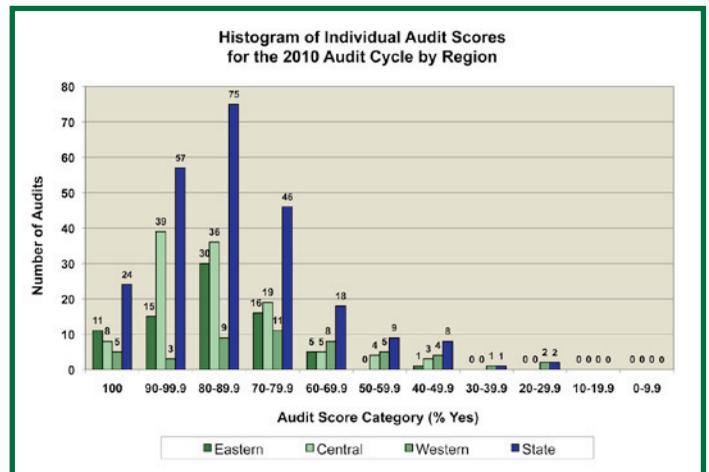
Figure 2: Score distribution of all 240 audits for the 2010 audit cycle in Virginia. Data labels indicate number of audits in each category.

Figure 2 indicates that the vast majority of tracts scored an overall implementation percentage of 70 percent or greater. While the overall mean implementation for all tracts is 82.7

percent (Table 2), the median is 84.4 percent. Given the slightly skewed distribution of the overall scores in Figure 2, the median is perhaps a better judge of central tendency of the data. This audit report include the expectation that all BMPs should be done per the manual regardless of likely impacts on water quality on each job. In most cases, BMPs that are not done do not directly impact water quality whether completed or not. These BMPs can be considered “luxury” BMPs as they are recommended by the manual but are not necessarily impacting water quality. Any BMP failures on the part of the operator that directly impact water quality are apparent in the significant risk and active sedimentation percentages as reported in Figure 3 and the following explanation. These singular failures are also handled through the VDOF silvicultural water quality law enforcement process.

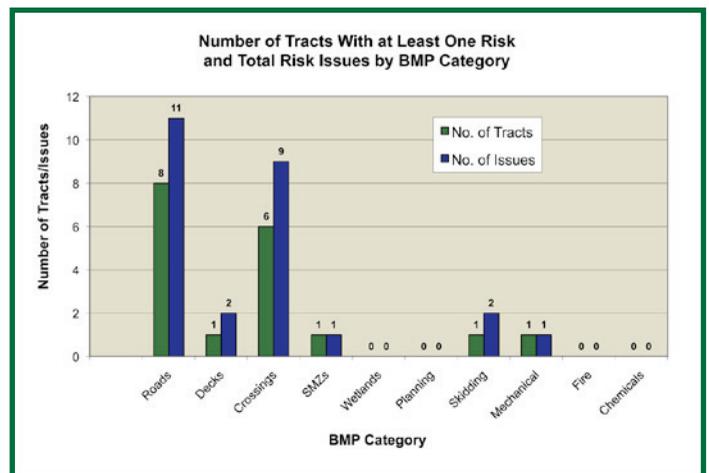
Figure 3: Number of audit tracts with at least one significant risk and total risk by BMP category. Some tracts had multiple risks in multiple categories.

It is apparent in Figure 3 that tracts which had at least one risk often had multiple risks. A second analysis including only tracts with at least one risk determined that the average percent Yes score for those 14 tracts was 68 percent, which indicates that significant risks to water quality tend to occur on tracts where overall BMP implementation is poor. Only
