Silvicultural Best Management Practices Implementation Monitoring for Virginia

2014

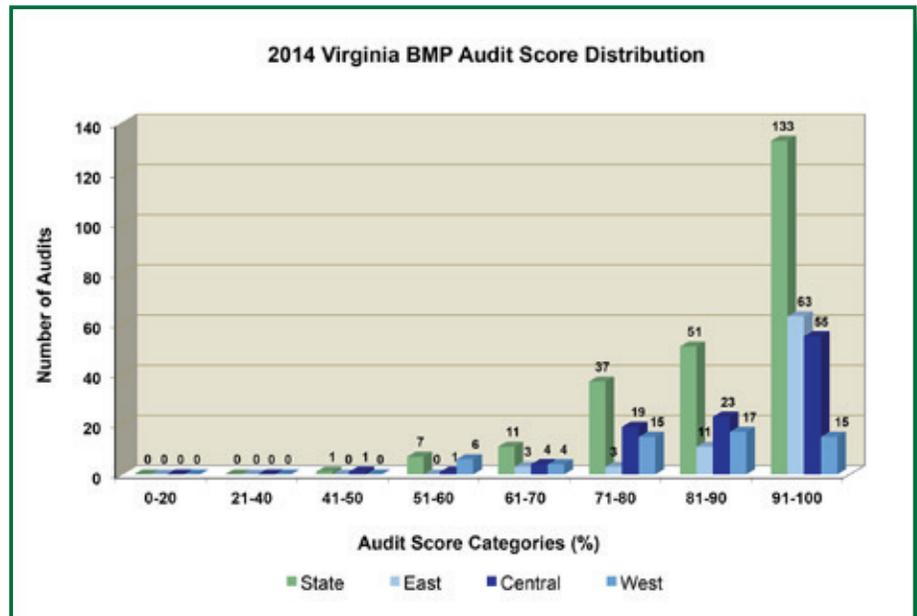
Figure 1: A histogram describing the score distribution of all 240 audits for the 2014 audit cycle in Virginia.

The histogram (Figure 1) indicates that the vast majority of tracts scored an overall implementation percentage of 81 percent or greater. While the overall mean BMP implementation for all tracts is 87.7 percent (Table 2) and the overall harvest average score is 87.8 percent, the harvest median score is 93 percent. Given the skewed distribution of the overall scores in Figure 1, the median is perhaps a better judge of central tendency of the tract score data. These results indicate a steady level of BMP implementation statewide over recent years, and it should be understood that random sample averages fluctuate over time and small year to year changes may not indicate a real change in BMP implementation. Any real changes will become apparent over the long term as more data are accumulated.
