# Silvicultural Best Management Practices Implementation Monitoring for Virginia

2020

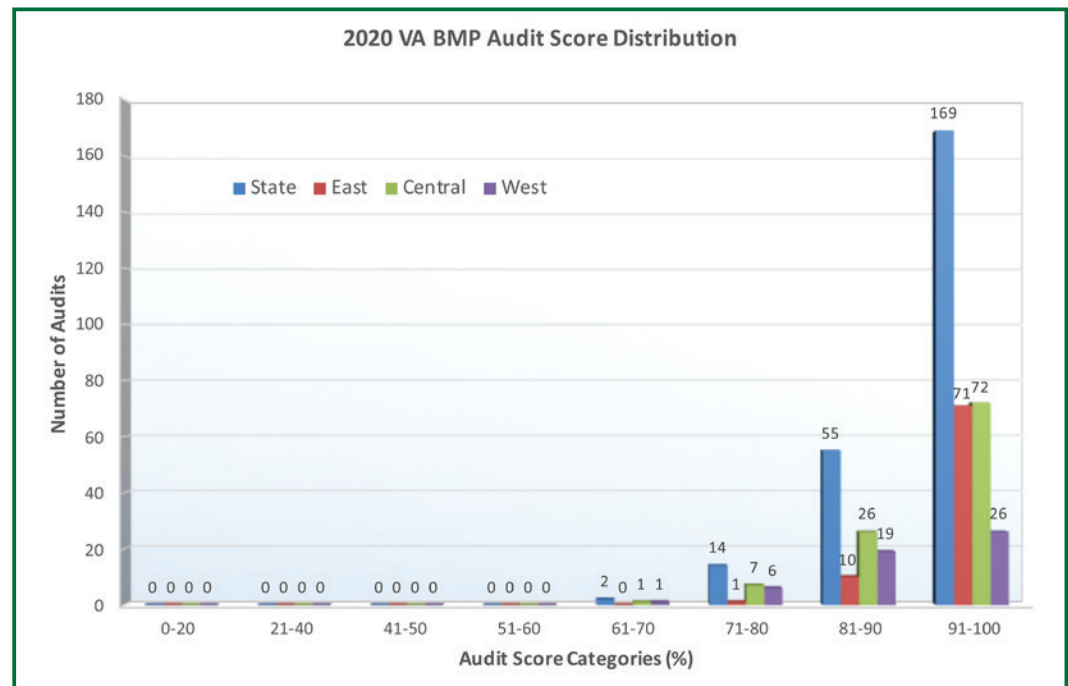
**Figure 1: A histogram describing the score distribution of all 240 audits for the 2020 audit cycle in Virginia.**

The histogram (Figure 1) indicates that the vast majority of tracts scored an overall implementation percentage of 81 percent or greater. While the overall mean BMP implementation for all tracts is 92.7 percent (Table 2) and the overall harvest average score is 92.78 percent, the harvest median score is 95.0 percent. Given the skewed distribution of the overall scores in Figure 1, the median is perhaps a better judge of central tendency of the tract score data. These results indicate a steady level of BMP implementation statewide over recent years, and it should be understood that random sample averages fluctuate over time and small year to year changes may not indicate a real change in BMP implementation. Any real changes will become apparent over the long term as more data are accumulated.
